# Intel® Xeon® Processor 5400 Series

Specification Update

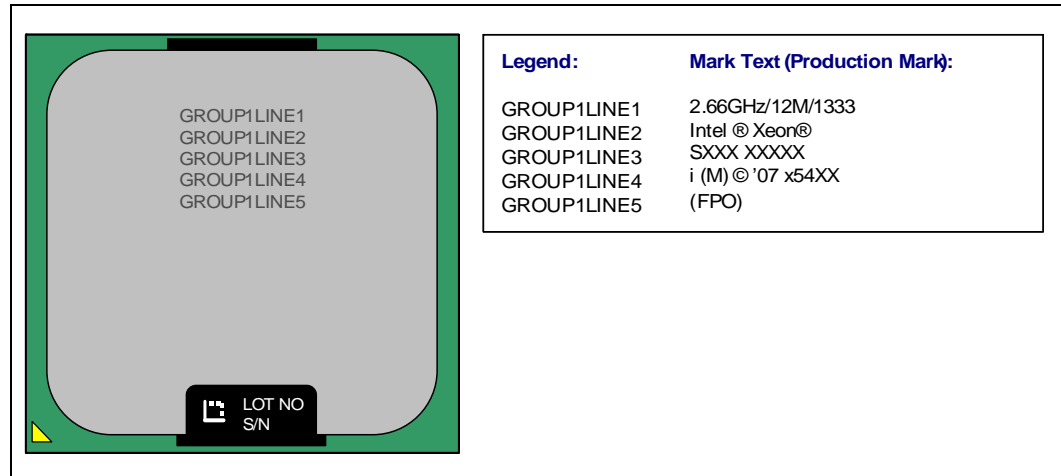
**Figure 1. Processor Top-side Markings (Example)**

Intel® Xeon® Processor 5400 Series stepping can be identified by the following component markings:
